#### **Public Charrette**

## Stock Island / Key Haven US-1 Corridor Enhancement Plan

Objective of study is to develop a Corridor Enhancement Plan of the Stock Island/Key Haven US-1 Corridor (MM 6 to MM 4.2)

Objective of Public Charrette is to discuss existing corridor conditions and formulate a corridor vision based on community and agency consensus

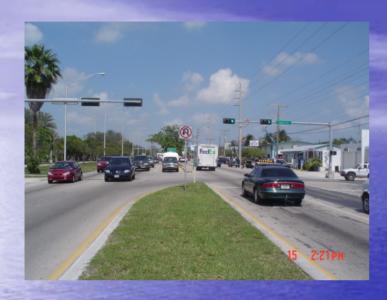
Vehicle Crash Data Analysis	
Year	Safety Ratio
2001	1.2
2002	<1.0
2003	<1.0
*Safety ratios less than 1.0 indicate no significant crash patterns

- Intersection crash data from the Florida Department of Transportation pertaining to the project corridor were examined.
- Rear-end vehicular crashes comprise a significant crash pattern within the project corridor.
- Rear-end crashes may be attributed to:
  - 1. Proximity of traffic signals, driveways and intersections
  - 2. Traffic congestion
  - 3. Absence of clearly designated driveways

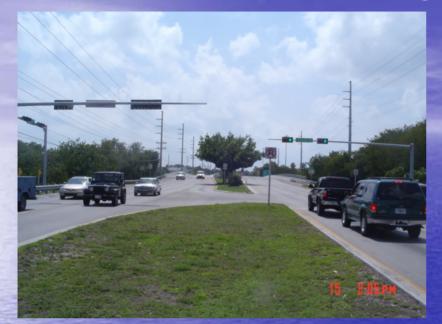
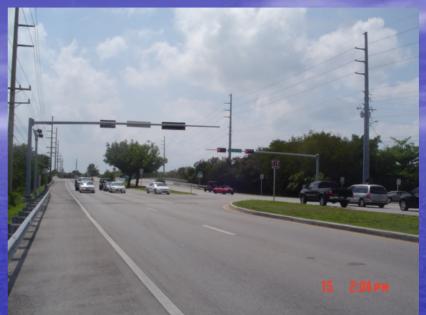
## Stock Island / Key Haven US-1 Corridor Enhancement Plan US-1 @ West College Road Intersection

- Intersection lacks pedestrian crosswalks, bicycle features, and accessibility to bus stops.
- ➤ Access to businesses along the Oceanside of the corridor is restricted at this intersection due to:
  - Lack of median openings
  - Prohibited U-Turns
- Existing median width does not adequately accommodate left turns.

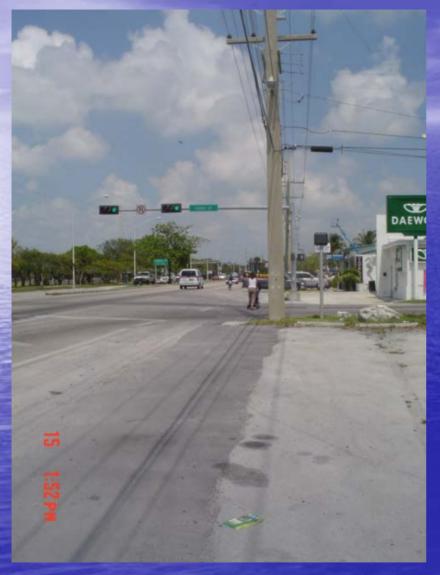
#### **US-1** @ Cross Street Intersection

- ► U-turns are currently prohibited at this intersection
- Exclusive westbound left turn lane is not long enough to accommodate existing high traffic volumes
- ➤ Signal timing is an area of concern
- Intersection features a crosswalk with signal; however, it lacks a sidewalk along the Oceanside

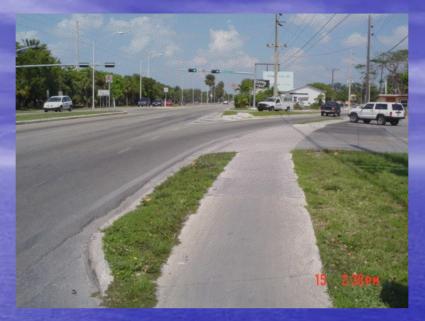
**US-1** @ Macdonald Avenue Intersection

- Intersection lacks a pedestrian signal
- Traffic signals are not clearly visible to pedestrians due to the signal's angle
- ➤ Posted speed limits are 35mph west of Macdonald Ave. and 45mph east of Macdonald Ave.
- ➤ Vehicles were observed traveling at high speeds via this free-flow right turn lane, raising concerns about pedestrian/bicycle safety

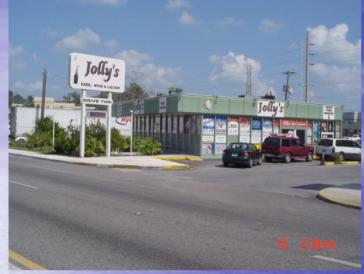
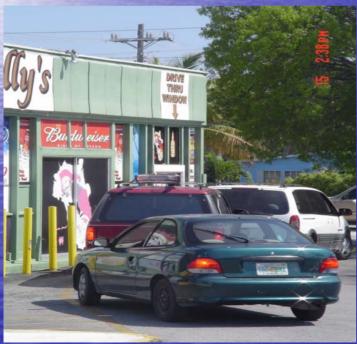
## Jolly's Beer, Wine, and Liquor near US-1 and 5<sup>th</sup> Street

Establishment features a drive though lane which may contribute to back-up traffic on US-1.

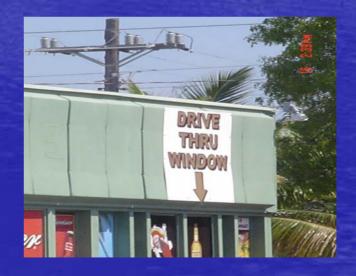
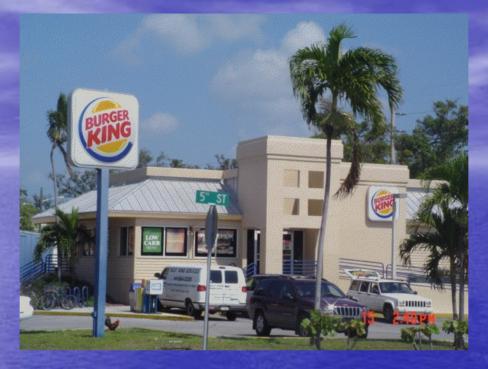
**Burger King Located at 5th Street and US-1**

- Intersection features:
  - Curb
  - Gutter
  - ADA ramps
- ➤ Area adjacent to Burger King on 5th Street consists of vacant lots and residential areas.

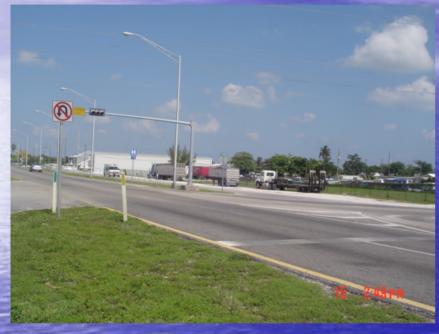
#### US-1 @ 3rd Street Intersection

- Frontage road east of 3rd Street is in close proximity to US-1, complicating movements at this intersection
- ➤ In the event frontage road is blocked, stopped traffic may be forced to back out onto US-1
- Residents have expressed concerns that blinking lights on northeast end, approaching MM5 do not effectively slow down motorists and draw attention to the community college

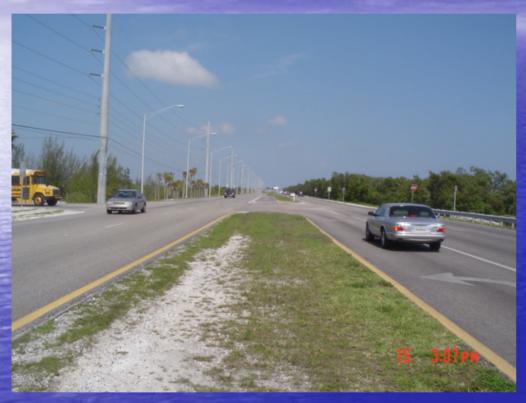
#### **US-1** @ Key Haven Road Intersection

- Two pedestrian crashes occurred at this intersection between 1991 and 1995.
- The following deficiencies were observed:
  - Lack of bicycle/pedestrian warning signs on Key Haven Road
  - 2. Inadequate street lighting

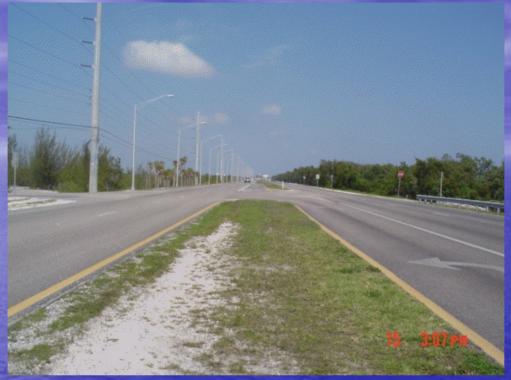
MM6/Boca Chica Bridge

- ► Bridge features a crossing allowing access to the Oceanside where there is an existing pedestrian path across the Boca Chica Channel.
- Currently, there is no functional bicycle path on the Boca Chica Bridge.

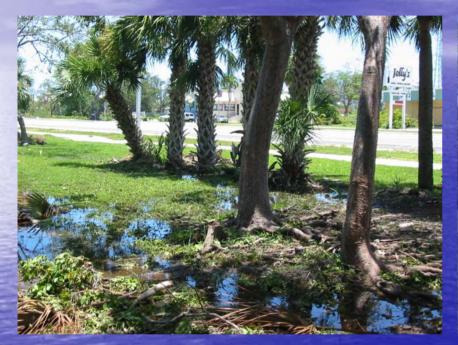
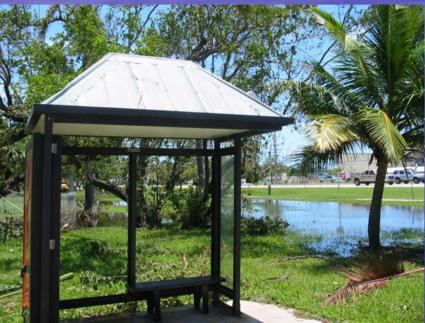
- ➤ Flooded areas along the golf course located on the bayside of the project corridor following Hurricane Dennis
- Photos were taken 3 days after Hurricane Dennis

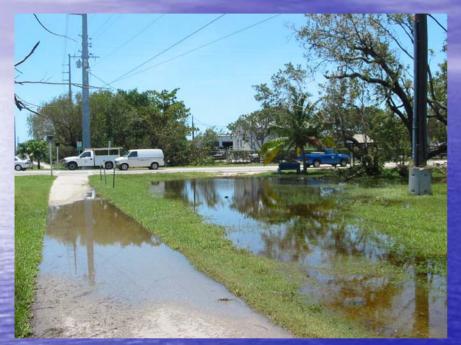
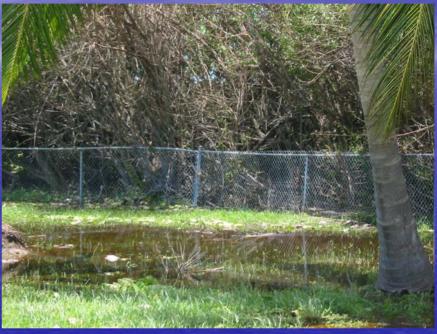
Flooding of the FKOHT at US-1 and College Road intersection restricts bicycle/pedestrian access.

Areas where water stagnates serves as a breeding ground for mosquitos.

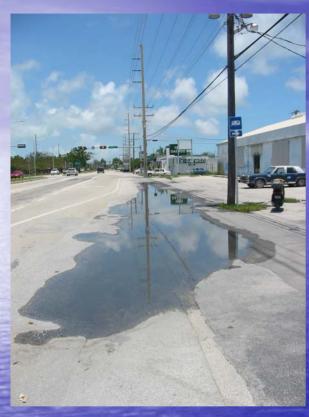
- Flooding restricted parking for this Water business located along the Oceanside of project corridor.
- Flooding also occurred near the Coral Hammock residential community located on the Oceanside of the project corridor.

Overall, businesses lining the southern portion of the project corridor were affected by flooding, restricting parking and access.

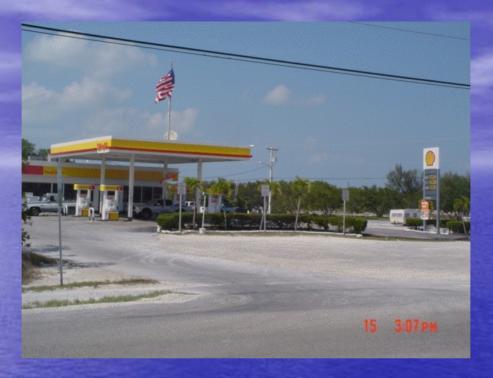
- Opportunities for enhancement of Key Haven Road intersection include:
  - Gateway features at the Key Haven entrance
  - 2. Rezoning land across from the Shell Station to residential uses

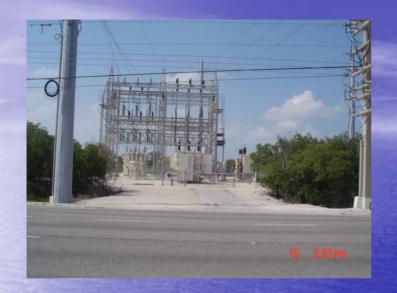
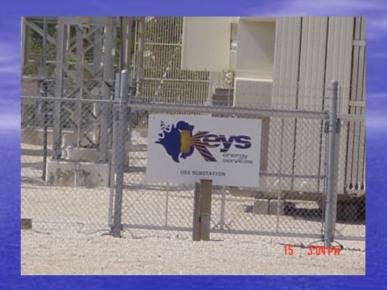
#### **Keys Energy Services US-1 Substation**

- Electrical substation located on the on the bayside of the project corridor should be screened with taller trees to assimilate the facility with existing surroundings.
- >Hurricane safety issues must be further examined before changes are made to surrounding substation landscaping.

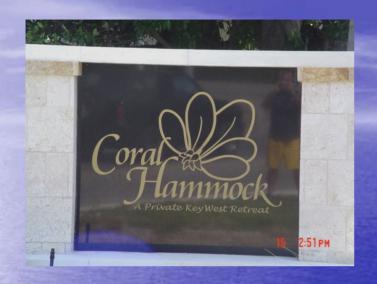
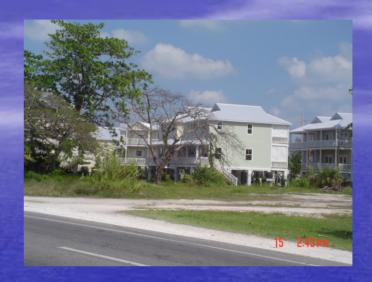
#### **Coral Hammock Residential Development**

- Wide area exists between Coral Hammock residential development fence and edge of US-1 pavement
- ➤ Proposed beautification includes seating under existing/saved ficus trees

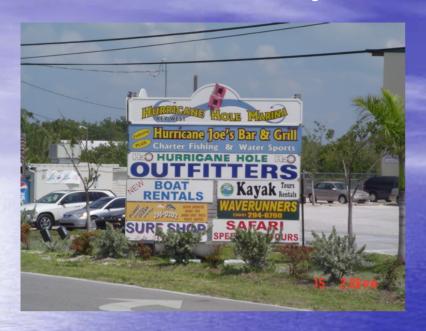
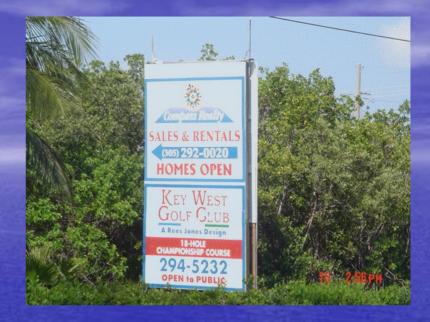
**Visual Clutter**

Implementation of signage guidelines would enhance visual quality along the corridor

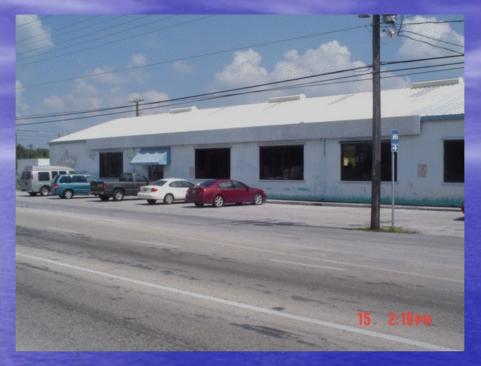
- Existing low lying power lines on the Oceanside of the corridor may impede proposed landscaping in this area.
- Alternatives to accommodate landscaping include:
  - 1. Relocating existing power lines behind these buildings
  - 2. Consolidating power lines to one side of US-1
  - 3. Burying existing lines
